QA-25
Wilson's Delight
Crumpton
Private

INVENTORY FORM FOR STATE HISTORIC SITES SURVEY

Wilson's Delight

WILSON'S DELIGHT
 CRUMPTON, MARYLAND

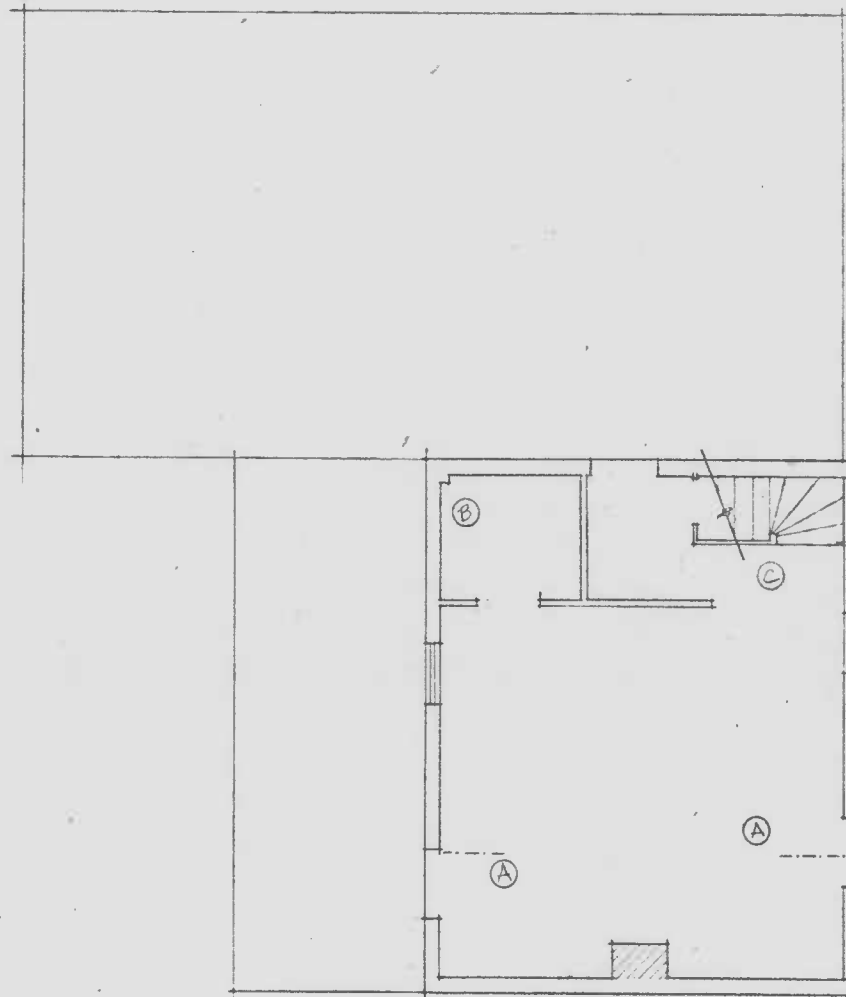
NOTE: EARLY STRUCTURE AND
 REAR PORCH NOW FORM REAR WING
 OF LATE 19TH CENTURY CENTER-
 HALL PLAN FARMHOUSE.

- A SEAM IN EXPOSED TOP PLATES
- B EXPOSED CORNER POST
- C VERTICAL FEATHER-EDGE PANEL-
 ING IN STAIR PARTITION
